**ARMY PRELIMINARY EVALUATION YAH-1R IMPROVED COBRA  
AGILITY AND MANEUVERABILITY HELICOPTER**

USAAEFA PROJECT NO. 74-33

## **FINAL REPORT**

**UNITED STATES ARMY AVIATION ENGINEERING FLIGHT ACTIVITY  
EDWARDS AIR FORCE BASE, CALIFORNIA 93523**

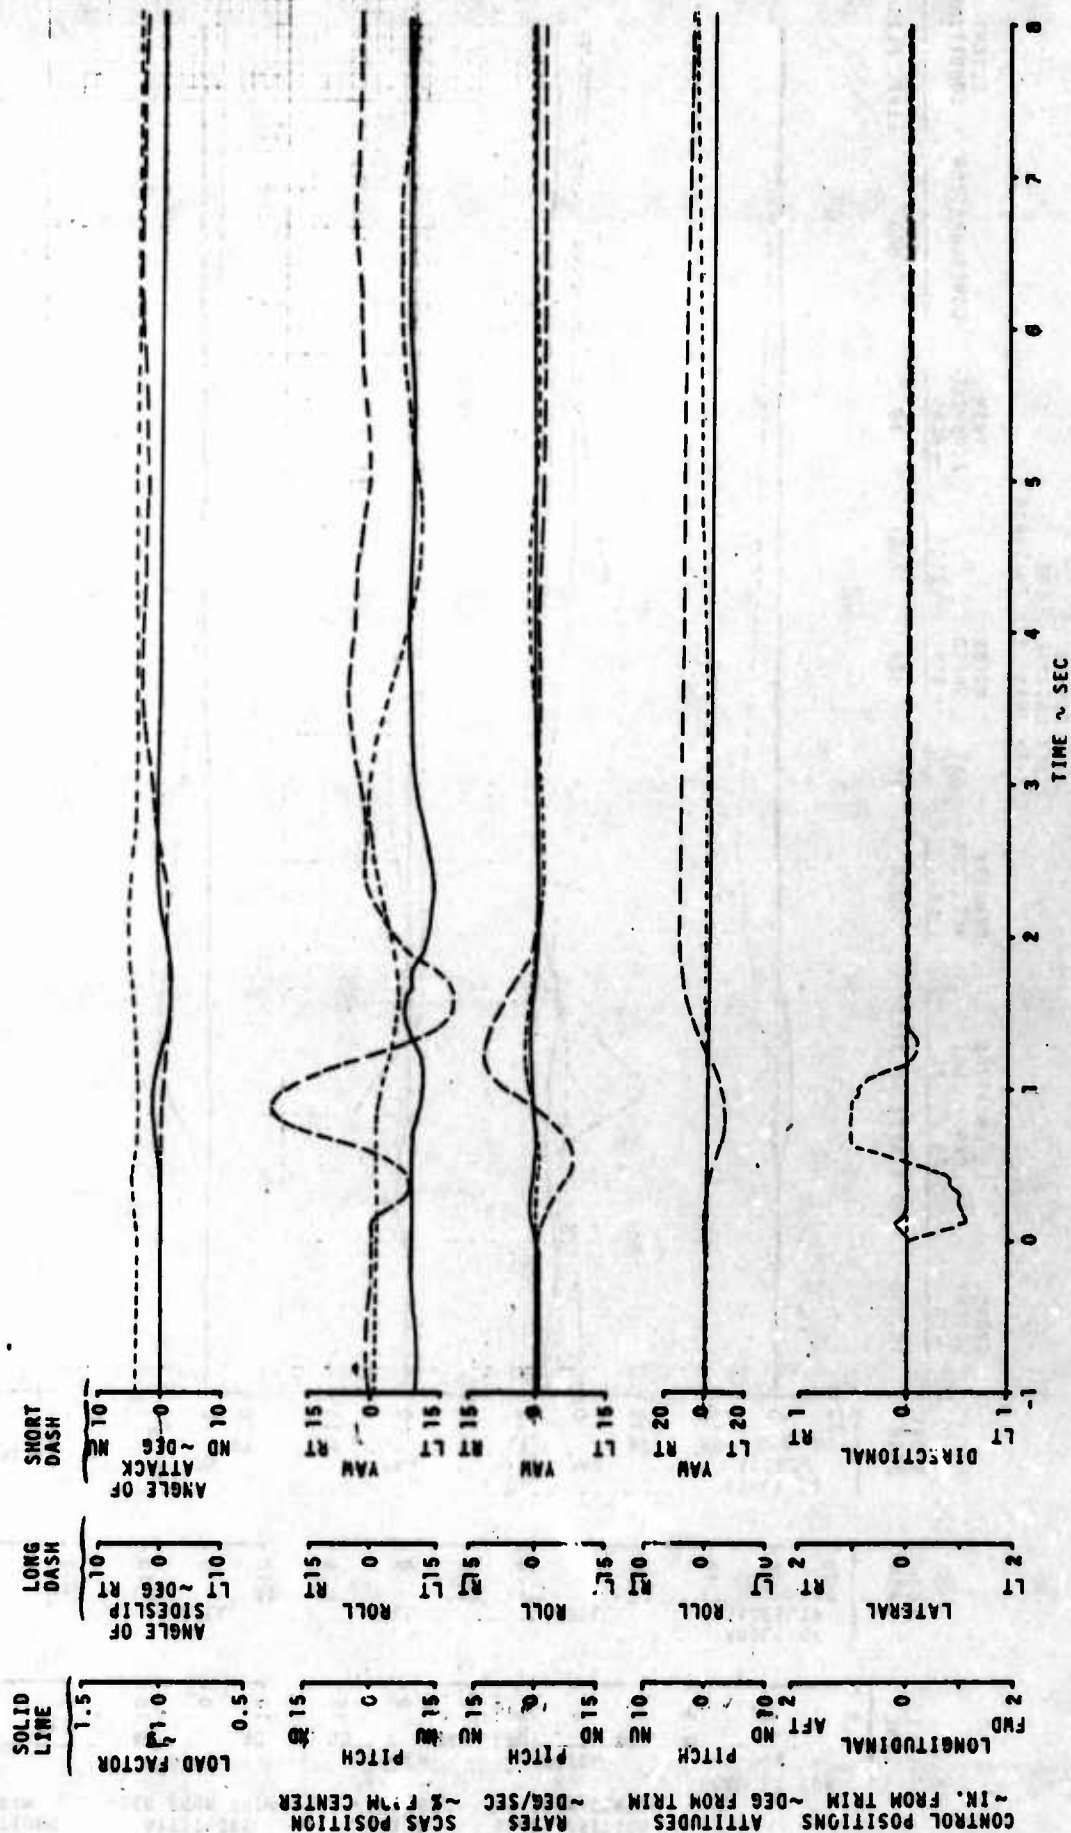
FIGURE 15  
LEFT LATERAL PULSE  
YAH-1R USA S/N 70-15936

GROSS WEIGHT ~LB	CG LOCATION LONG FS LAT BL	DENSITY ALTITUDE ~FT	OAT ~°C	ROTOR SPEED ~RPM	$C_T \times 10^4$	TRIM AIRSPEED ~KCAS	CONFIGURATION	FLIGHT CONDITION
9980	199.5(AFT) -0.1(LT)	5000	10	324	57.52	45	H06	LEVEL FLIGHT

20. The longitudinal and lateral-directional dynamic stability of the YAH-1R helicopter was evaluated at the conditions shown in table 1 with SCAS ON and SCAS OFF. Short-term dynamic responses, simulating gust response, were evaluated by rapidly pulsing the cyclic control and pedals 1 inch for a duration of approximately 1/2 second, then returning the control to the trim position. Short-term response was further evaluated by control doublets. Time histories of representative dynamic responses are presented in figures 13 through 24, appendix E.

22. The principal response mode of the YAH-1R helicopter to external gust input was a coupled roll-yaw oscillation (Dutch roll). Time histories of this response mode are shown in figures 13 through 24, appendix E. Although this oscillation was noticeable in flight with SCAS ON, it was positively damped without pilot input and easily damped by the pilot to achieve satisfactory flight conditions to launch rockets (HQRS 3). With SCAS OFF, the lateral-directional oscillation was lightly damped and easily excited by external gusts; however, the aircraft handling qualities are acceptable for flight in this degraded mode. Maintaining an airspeed below 100 KIAS for SCAS OFF flight, as currently recommended for the AH-1G, reduces pilot effort. Qualitatively, the YAH-1R short-period dynamics are similar to the standard AH-1G at a power setting of 1100 shp or below. At power settings above 1100 shp, the SCAS-OFF divergence is more pronounced.

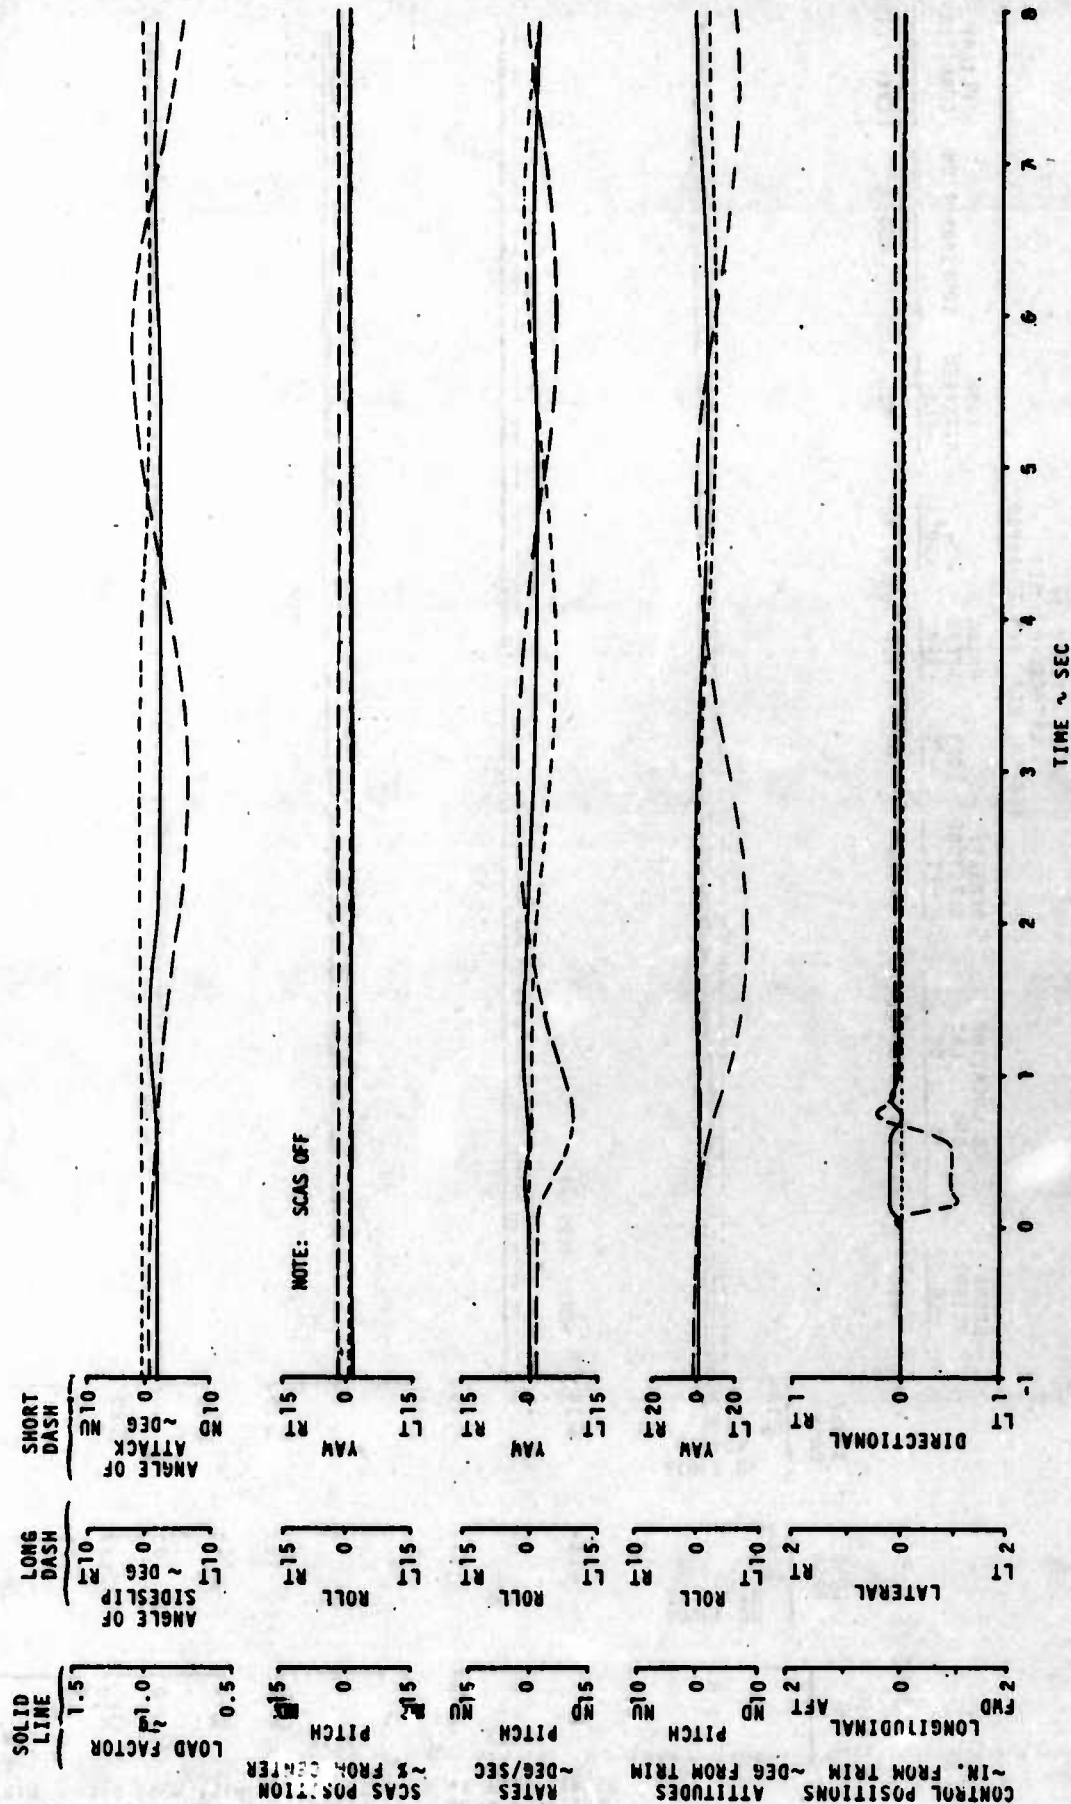
FIGURE 16  
LATERAL DOUBLET  
YAH-1R USA S/N 70-15936

GROSS WEIGHT ~LB	CG LOCATION LONG FS LAT BL	DENSITY ALTITUDE ~FT	OAT ~°C	ROTOR SPEED ~RPM	C x10 <sup>4</sup>	TRIM AIRSPEED ~KCAS	CONFIGURATION	FLIGHT CONDITION
9960	199.5(AFT) -0.1(LT)	5000	10	324	57.40	45	HOG	LEVEL FLIGHT

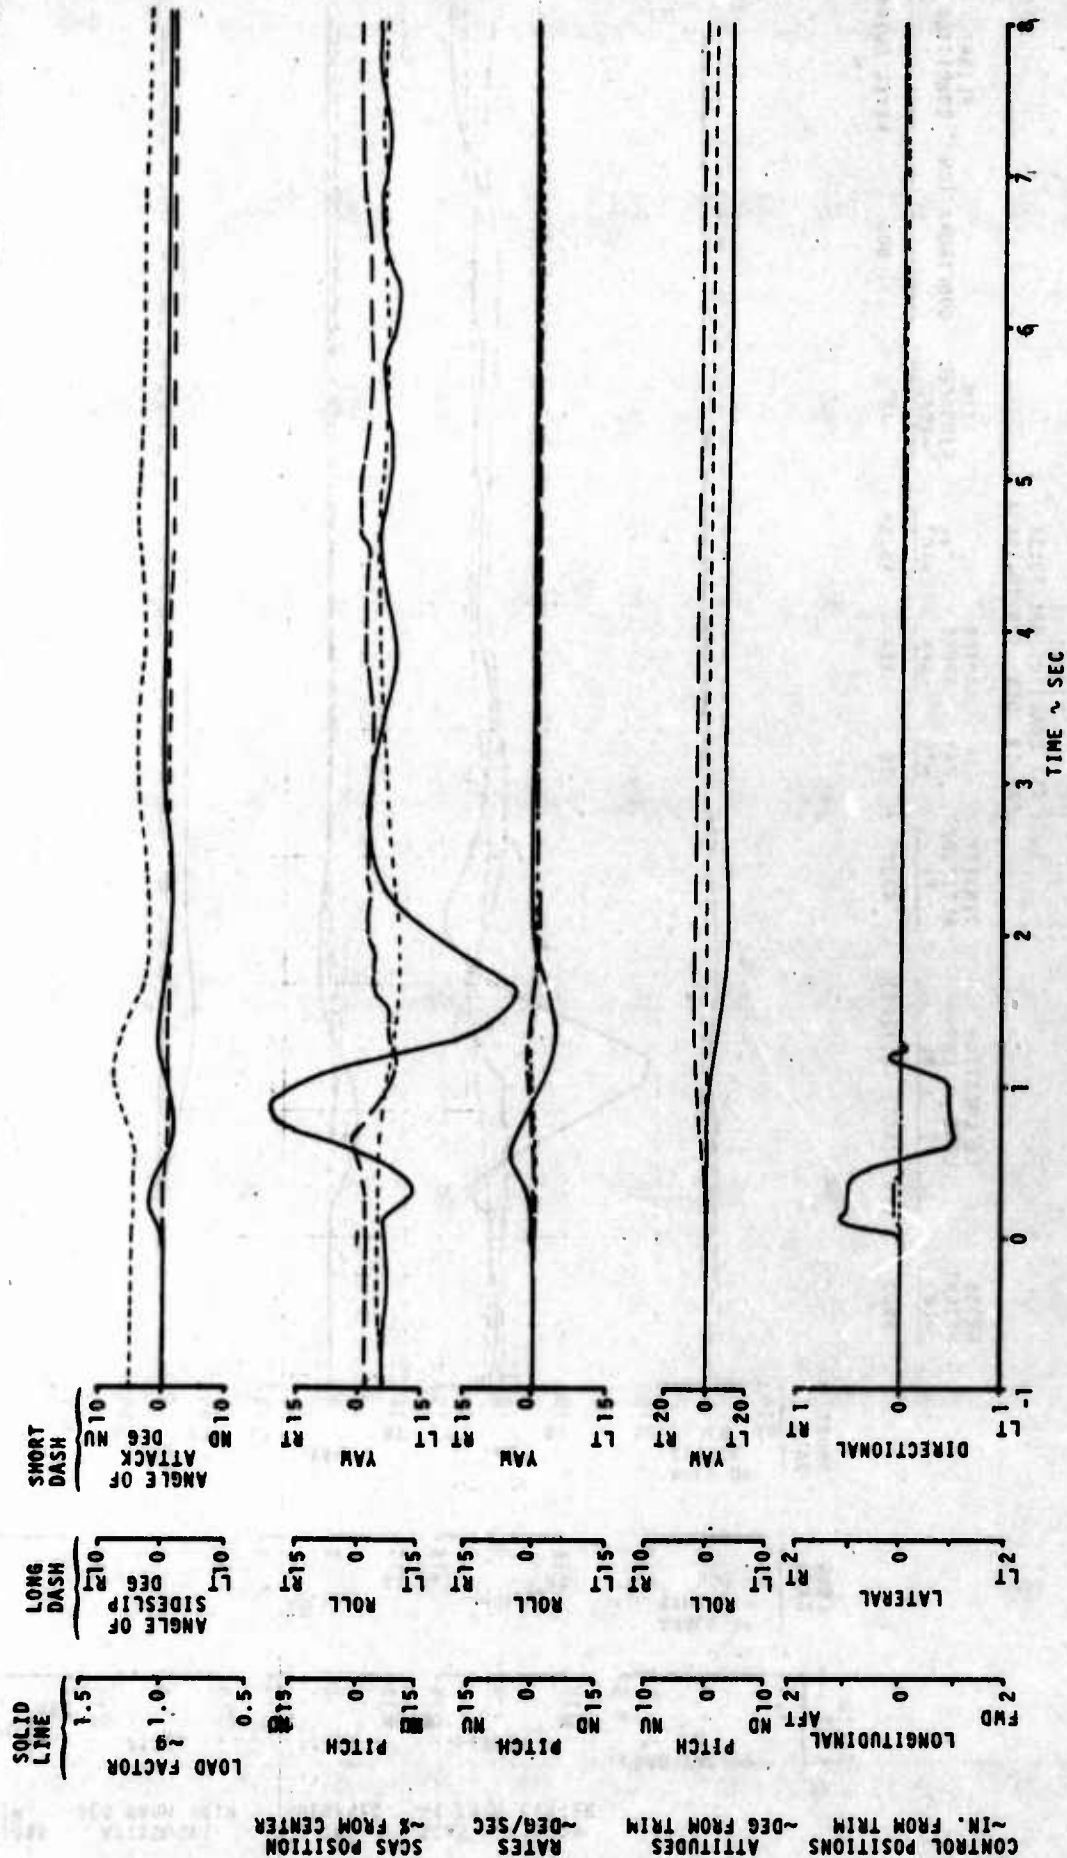
FIGURE 19  
AFT LONGITUDINAL PULSE  
YAH-IR USA S/N 70-15936

GROSS WEIGHT ~LB	CG LOCATION LONG FS LAT BL	DENSITY ALTITUDE ~FT	OAT ~°C	ROTOR SPEED ~RPM	C <sub>T</sub> x10 <sup>4</sup>	TRIM AIRSPEED ~KCAS	CONFIGURATION	FLIGHT CONDITION
9850	199.4(AFT) -0.1(LT)	4700	10	324	56.26	45	HOG	LEVEL FLIGHT

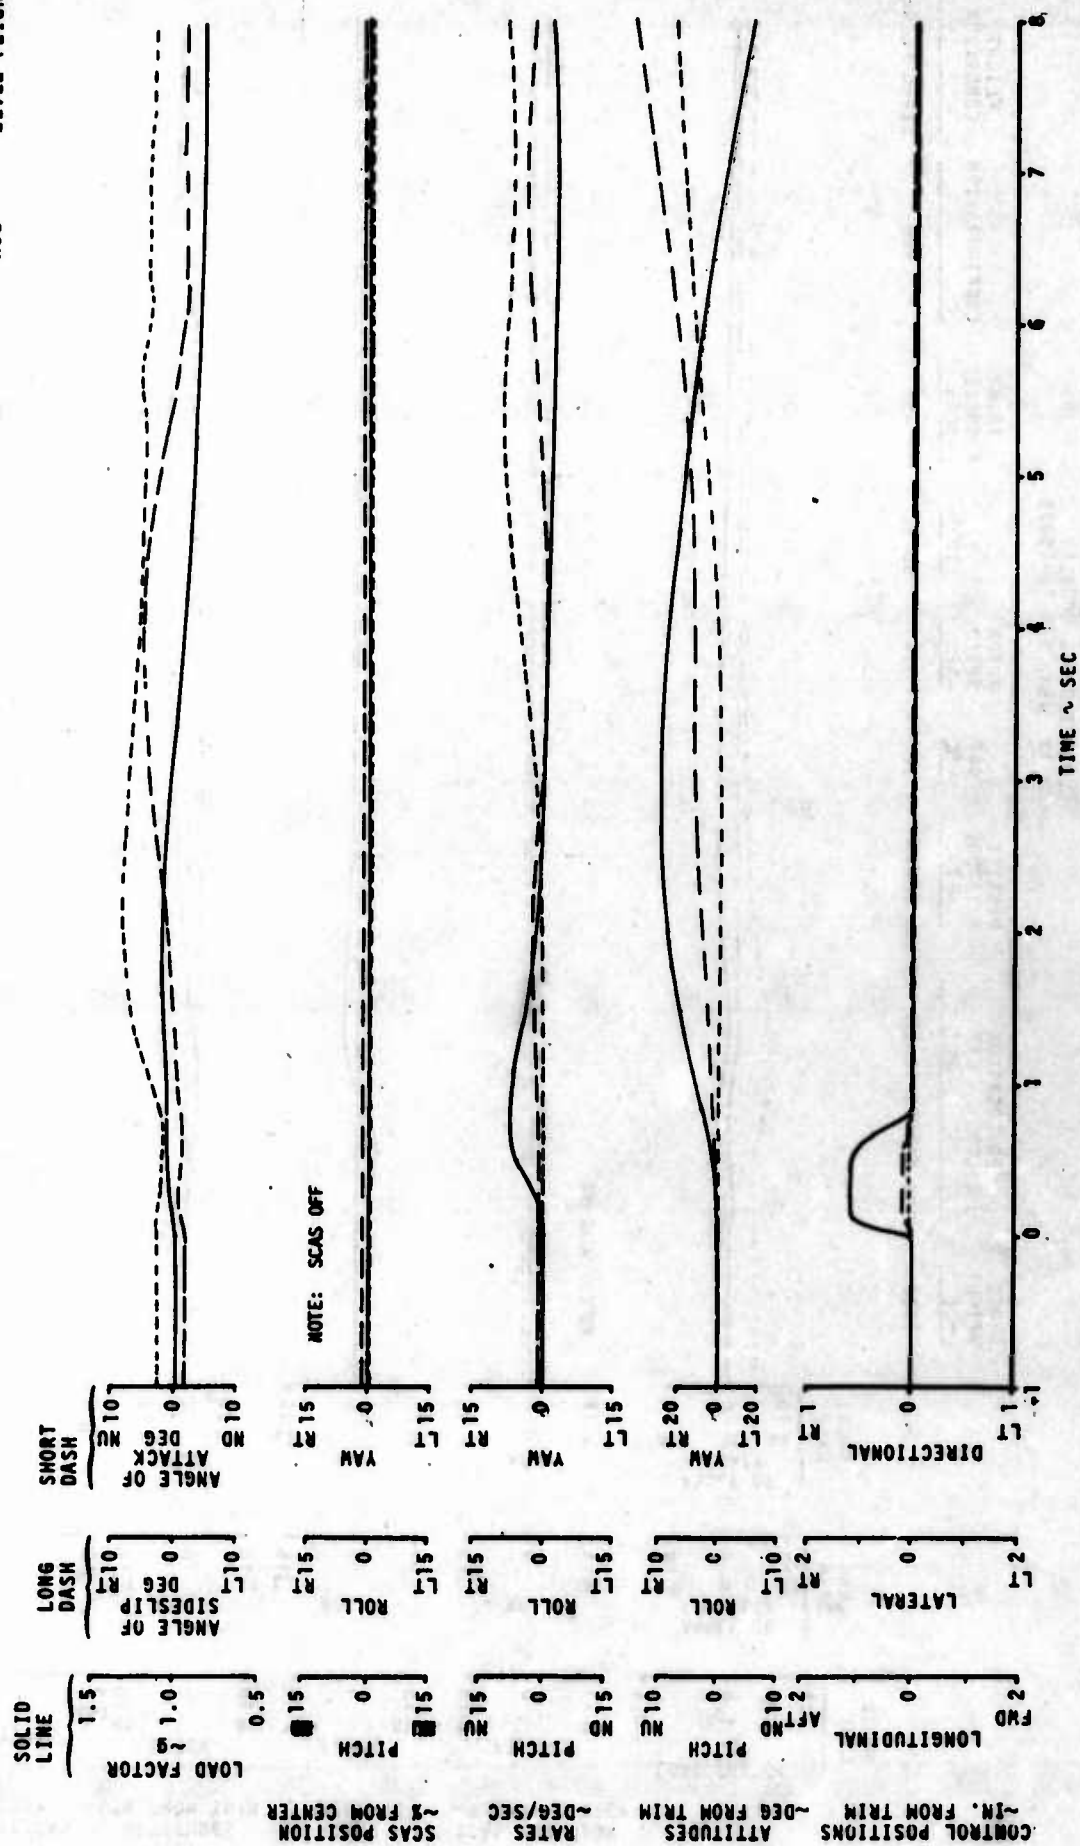
FIGURE 20  
LONGITUDINAL DOUBLET  
YAH-IR USA S/N 70-15936

GROSS WEIGHT ~LB	CG LOCATION LONG FS LAT BL	DENSITY ALTITUDE ~FT	OAT ~°C	ROTOR SPEED ~RPM	$C_T \times 10^4$	TRIM AIRSPEED ~KCAS	CONFIGURATION	FLIGHT CONDITION
9830	199.4(AFT) -0.1(LT)	4700	10	324	56.14	45	M06	LEVEL FLIGHT

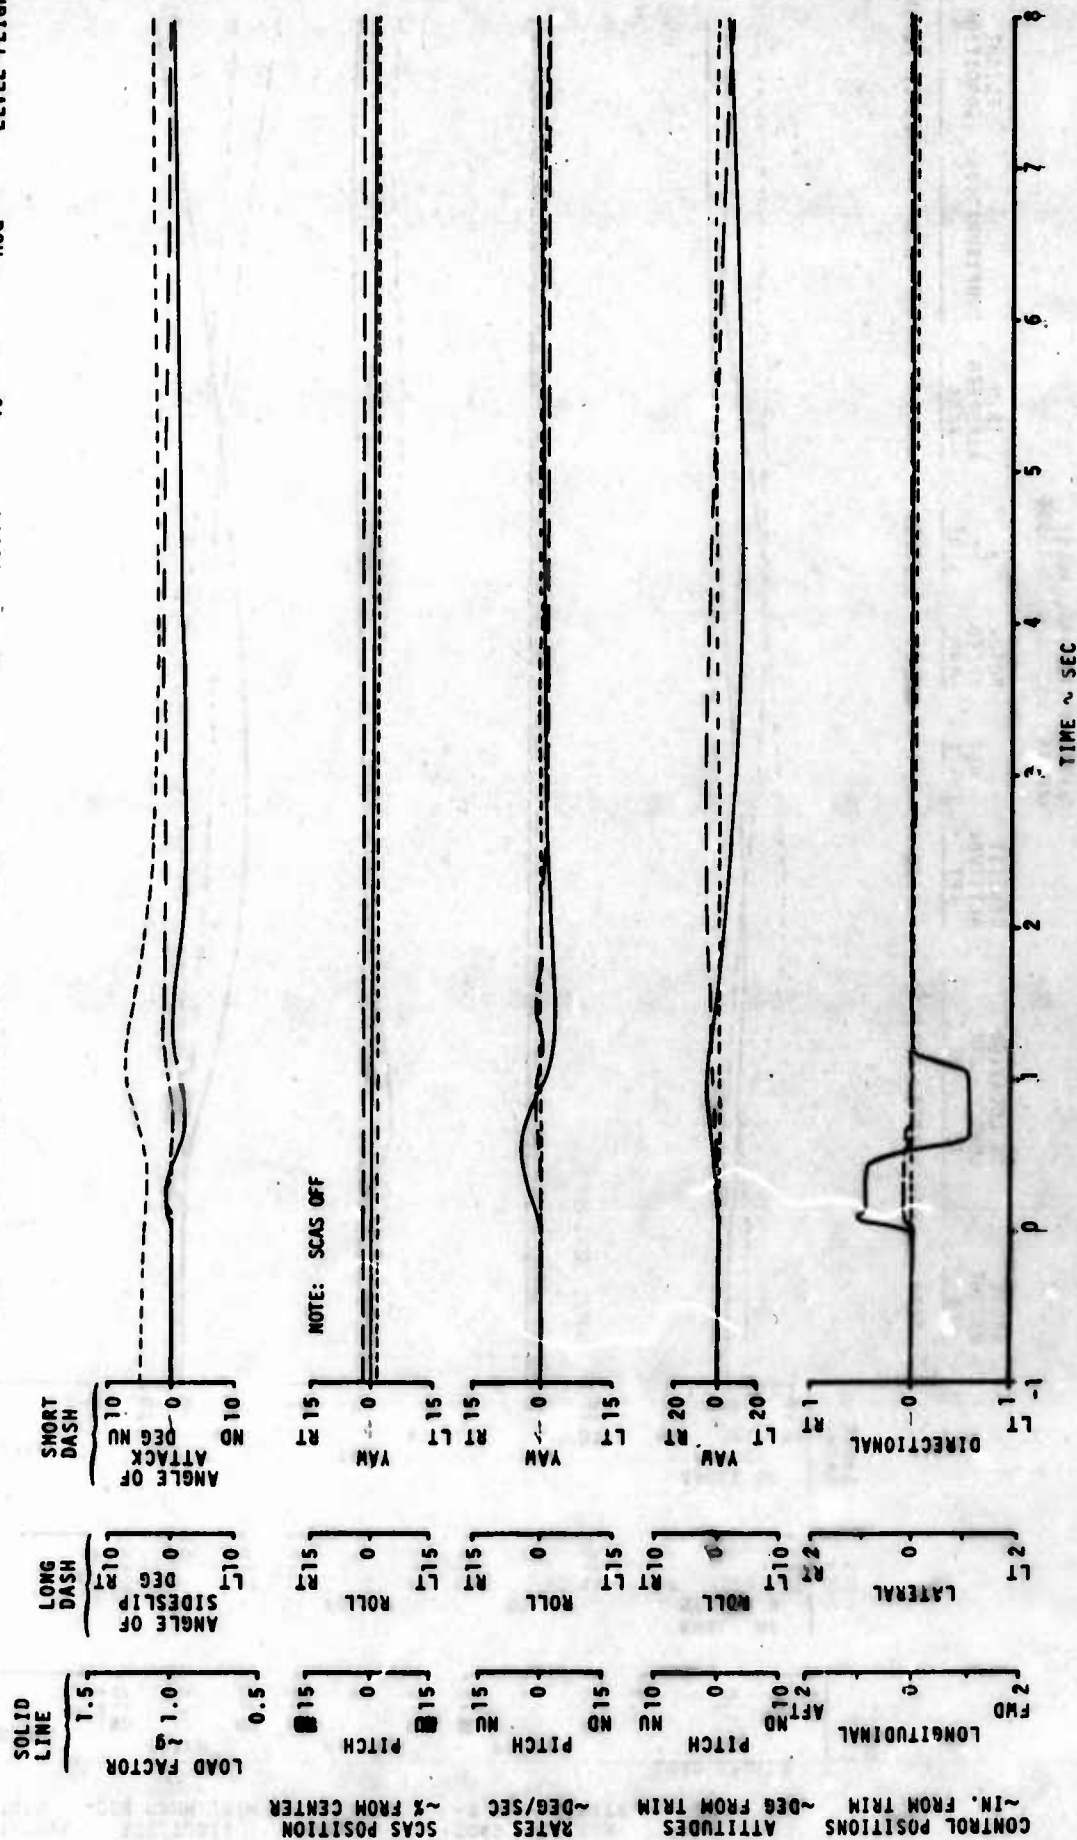
FIGURE 21  
LEFT DIRECTIONAL PULSE  
YAH-1R USA S/N 70-15936

GROSS WEIGHT		CG LOCATION		DENSITY ALTITUDE		ROTOR SPEED		TRIM AIRSPEED		CONFIGURATION		FLIGHT CONDITION	
~LB		LONG FS	LAT BL	~FT		~RPM		~KCAS					
9780		199.3(AFT)	-0.1(LT)	4800		324		45		HOG		LEVEL FLIGHT

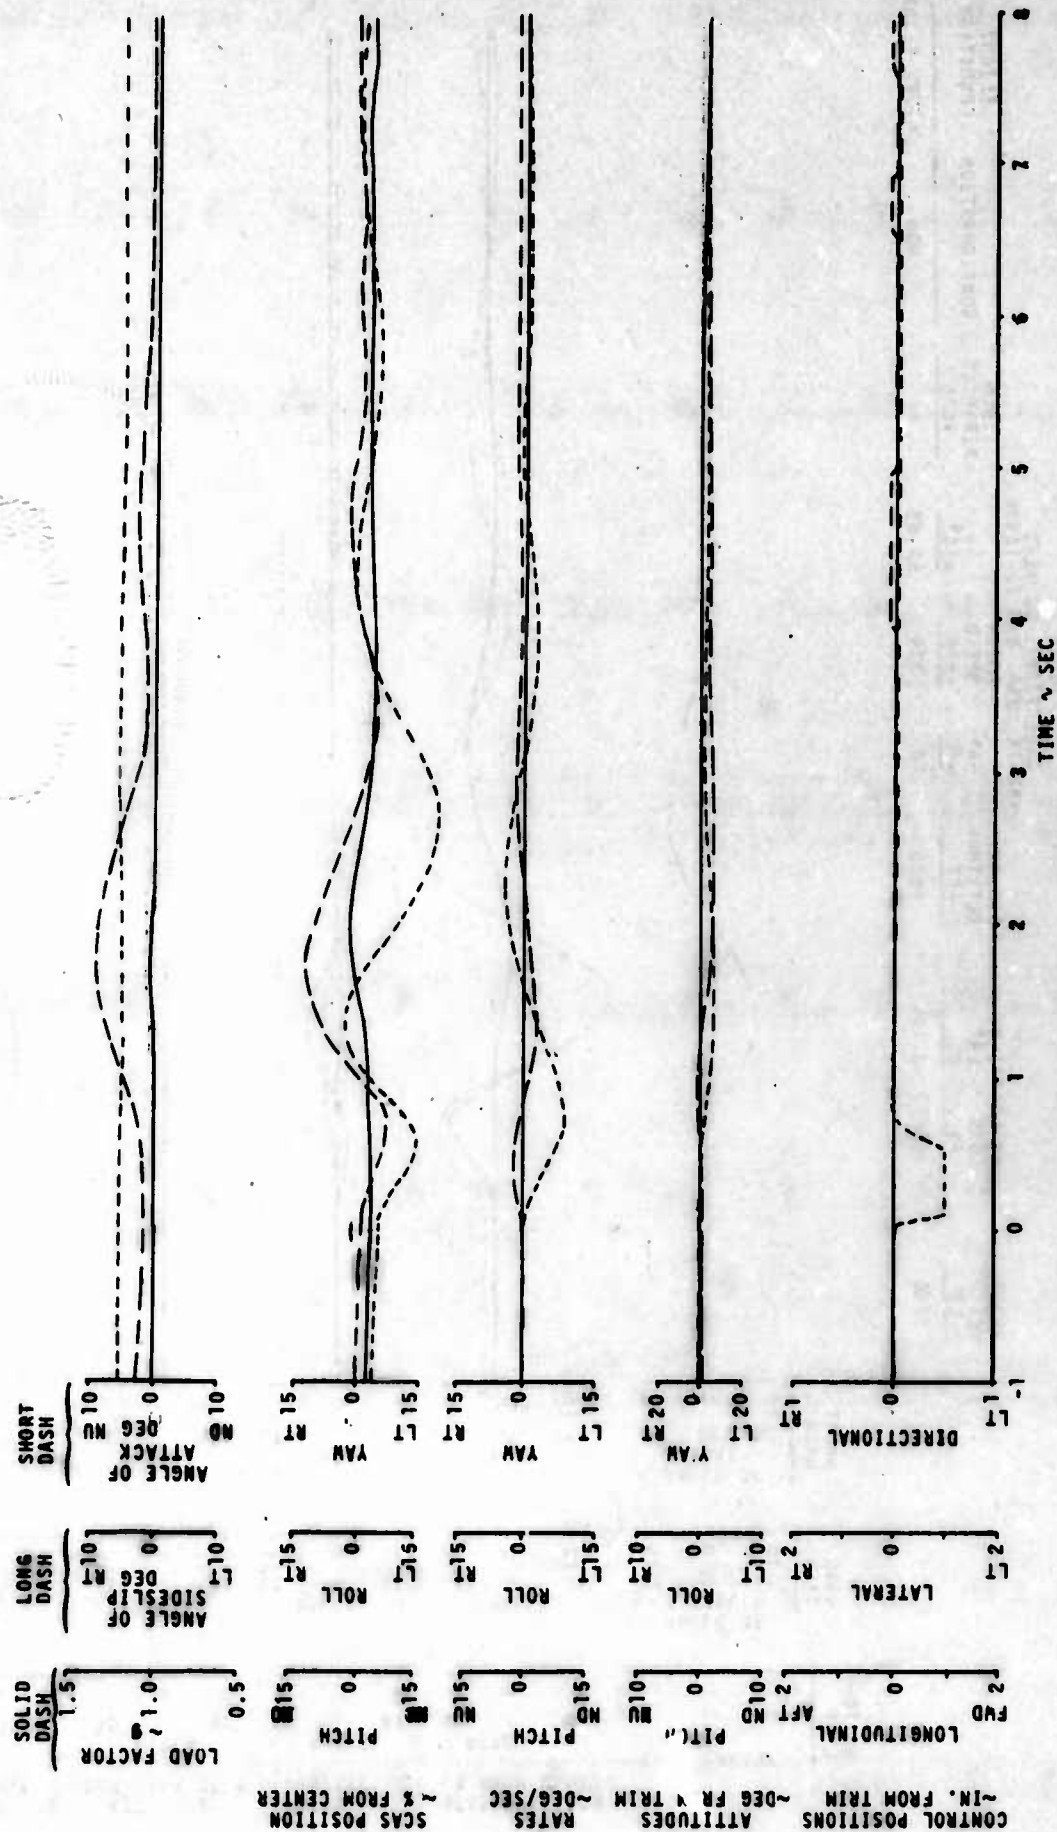
FIGURE 22  
DIRECTIONAL DOUBLET  
YAH-1R USA S/N 70-15936

GROSS WEIGHT ~LB	CG LOCATION LONG FS LAT BL	DENSITY ALTITUDE ~FT	OAT ~°C	ROTOR SPEED ~RPM	TRIM AIRSPEED ~KCAS	CONFIGURATION	FLIGHT CONDITION
9750	199.3(AFT) -0.1(LT)	4800	10	324	45	HOG	LEVEL FLIGHT

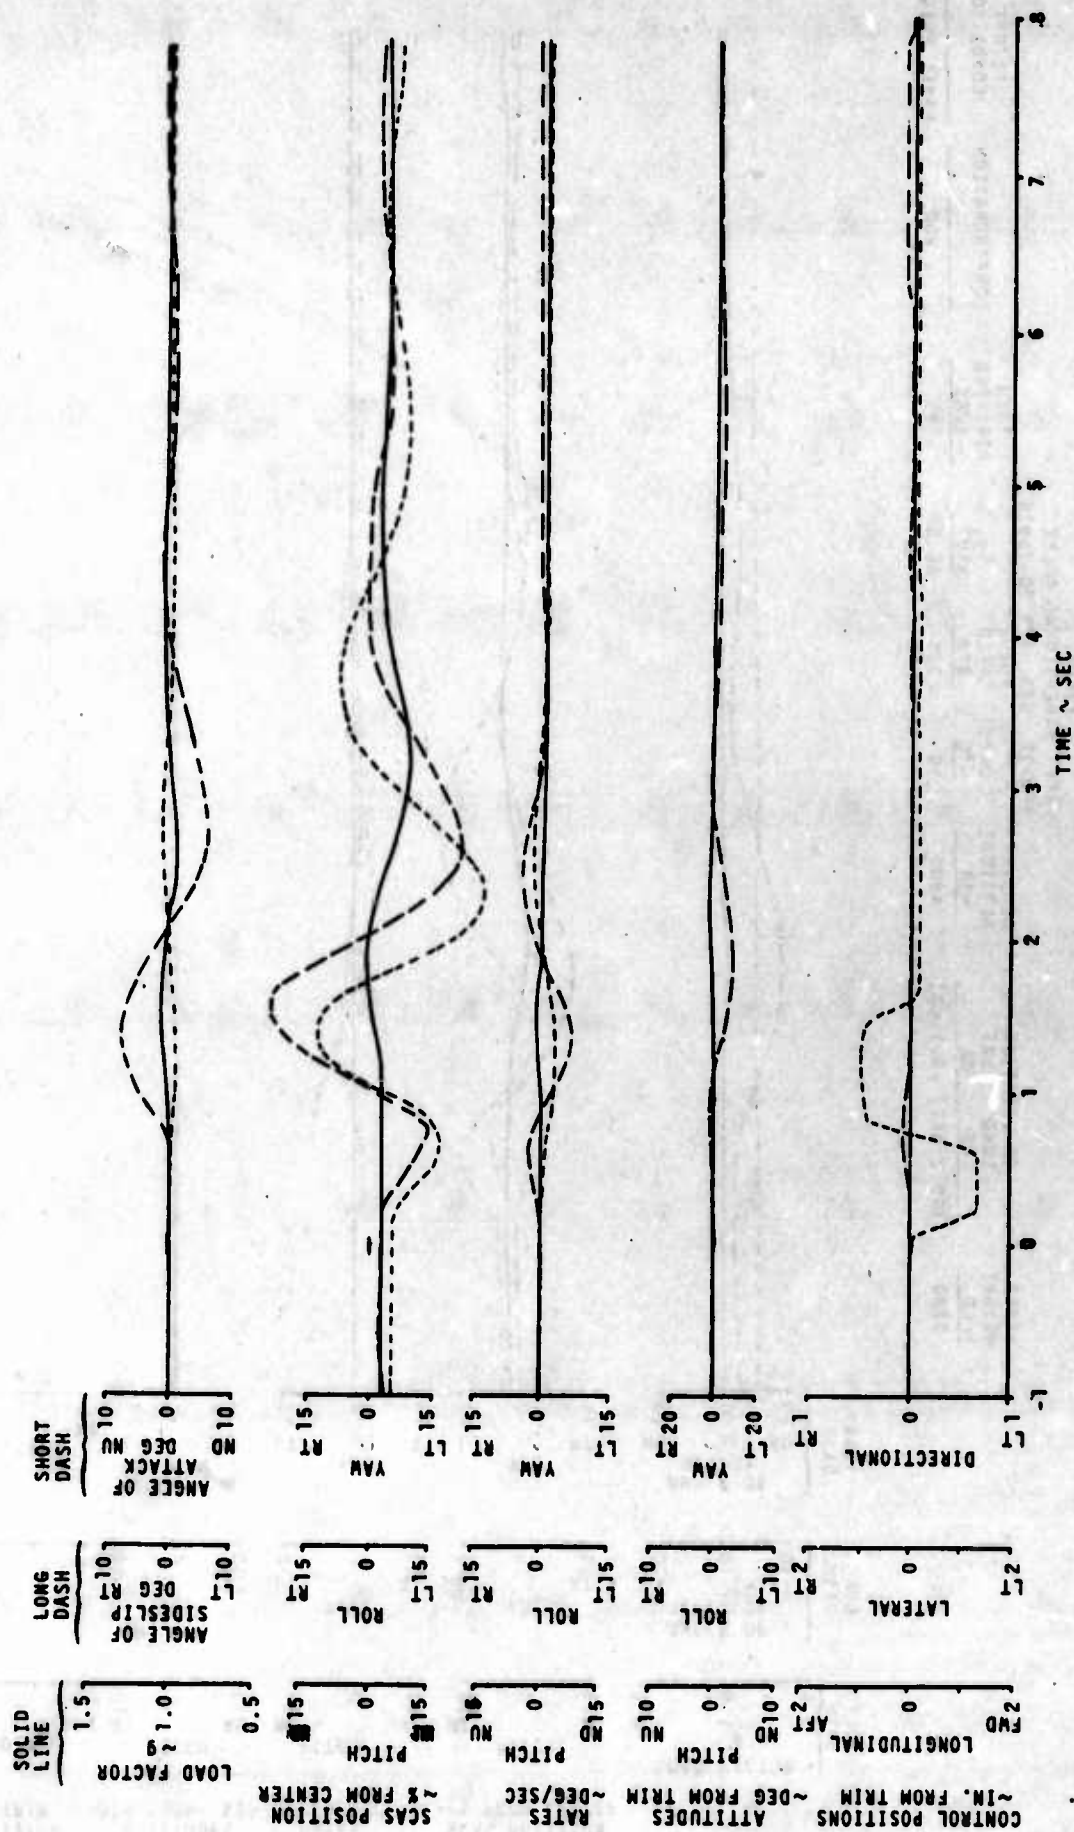
FIGURE 23  
LEFT DIRECTIONAL PULSE  
YAH-1R USA S/N 15936

GROSS WEIGHT ~LB	CG LOCATION		DENSITY ALTITUDE ~FT	OAT ~°C	ROTOR SPEED ~RPM	C <sub>T</sub> x10 <sup>4</sup>	TRIM AIRSPEED ~KCAS	CONFIGURATION	FLIGHT CONDITION
	LONG FS	LAT BL							
9720	199.3(AFT)	-0.1(LT)	4800	10	324	55.68	45	HOG	LEVEL FLIGHT

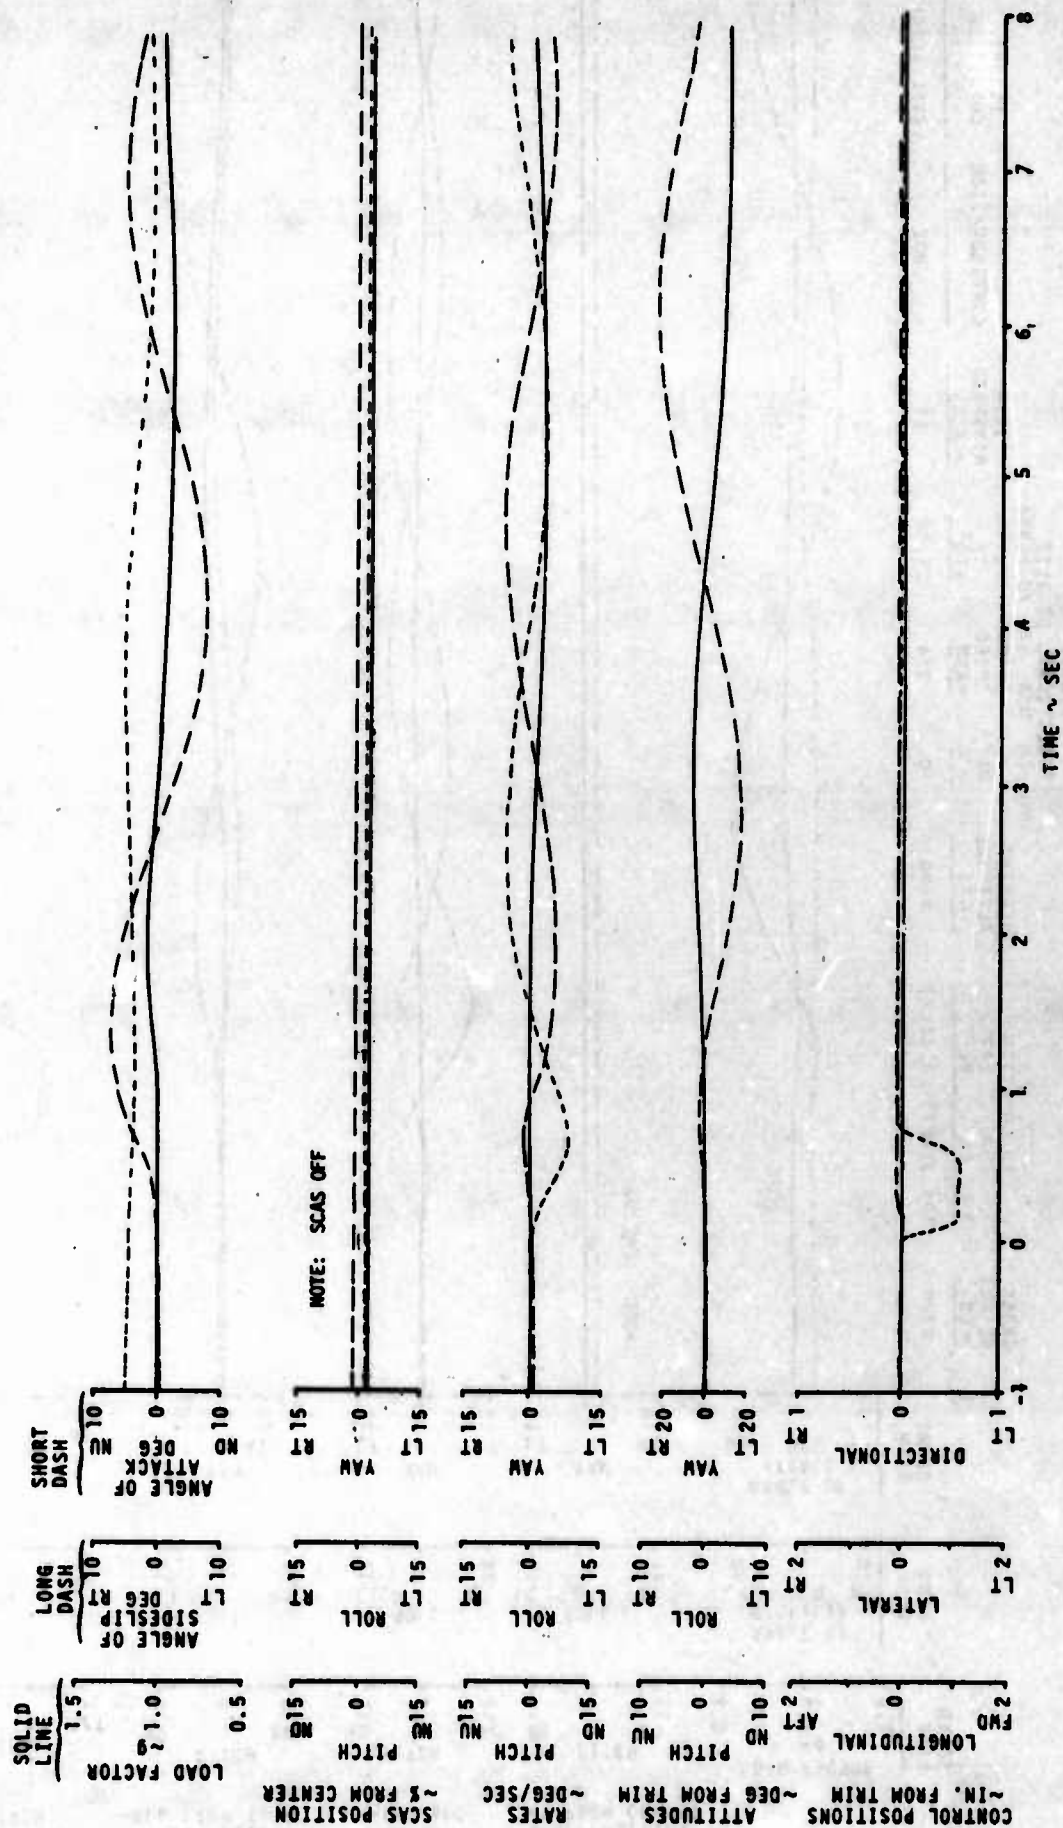
FIGURE 24  
DIRECTIONAL DOUBLET  
YAH-1R USA S/N 70-15936

GROSS WEIGHT ~LB	CG LOCATION LONG FS LAT BL	DENSITY ALTITUDE ~FT	OAT ~°C	ROTOR SPEED ~RPM	TRIM AIRSPEED ~KCAS	CONFIGURATION	FLIGHT CONDITION
9700	199.3(AFT)	4800	10	324	45	HOG	LEVEL FLIGHT

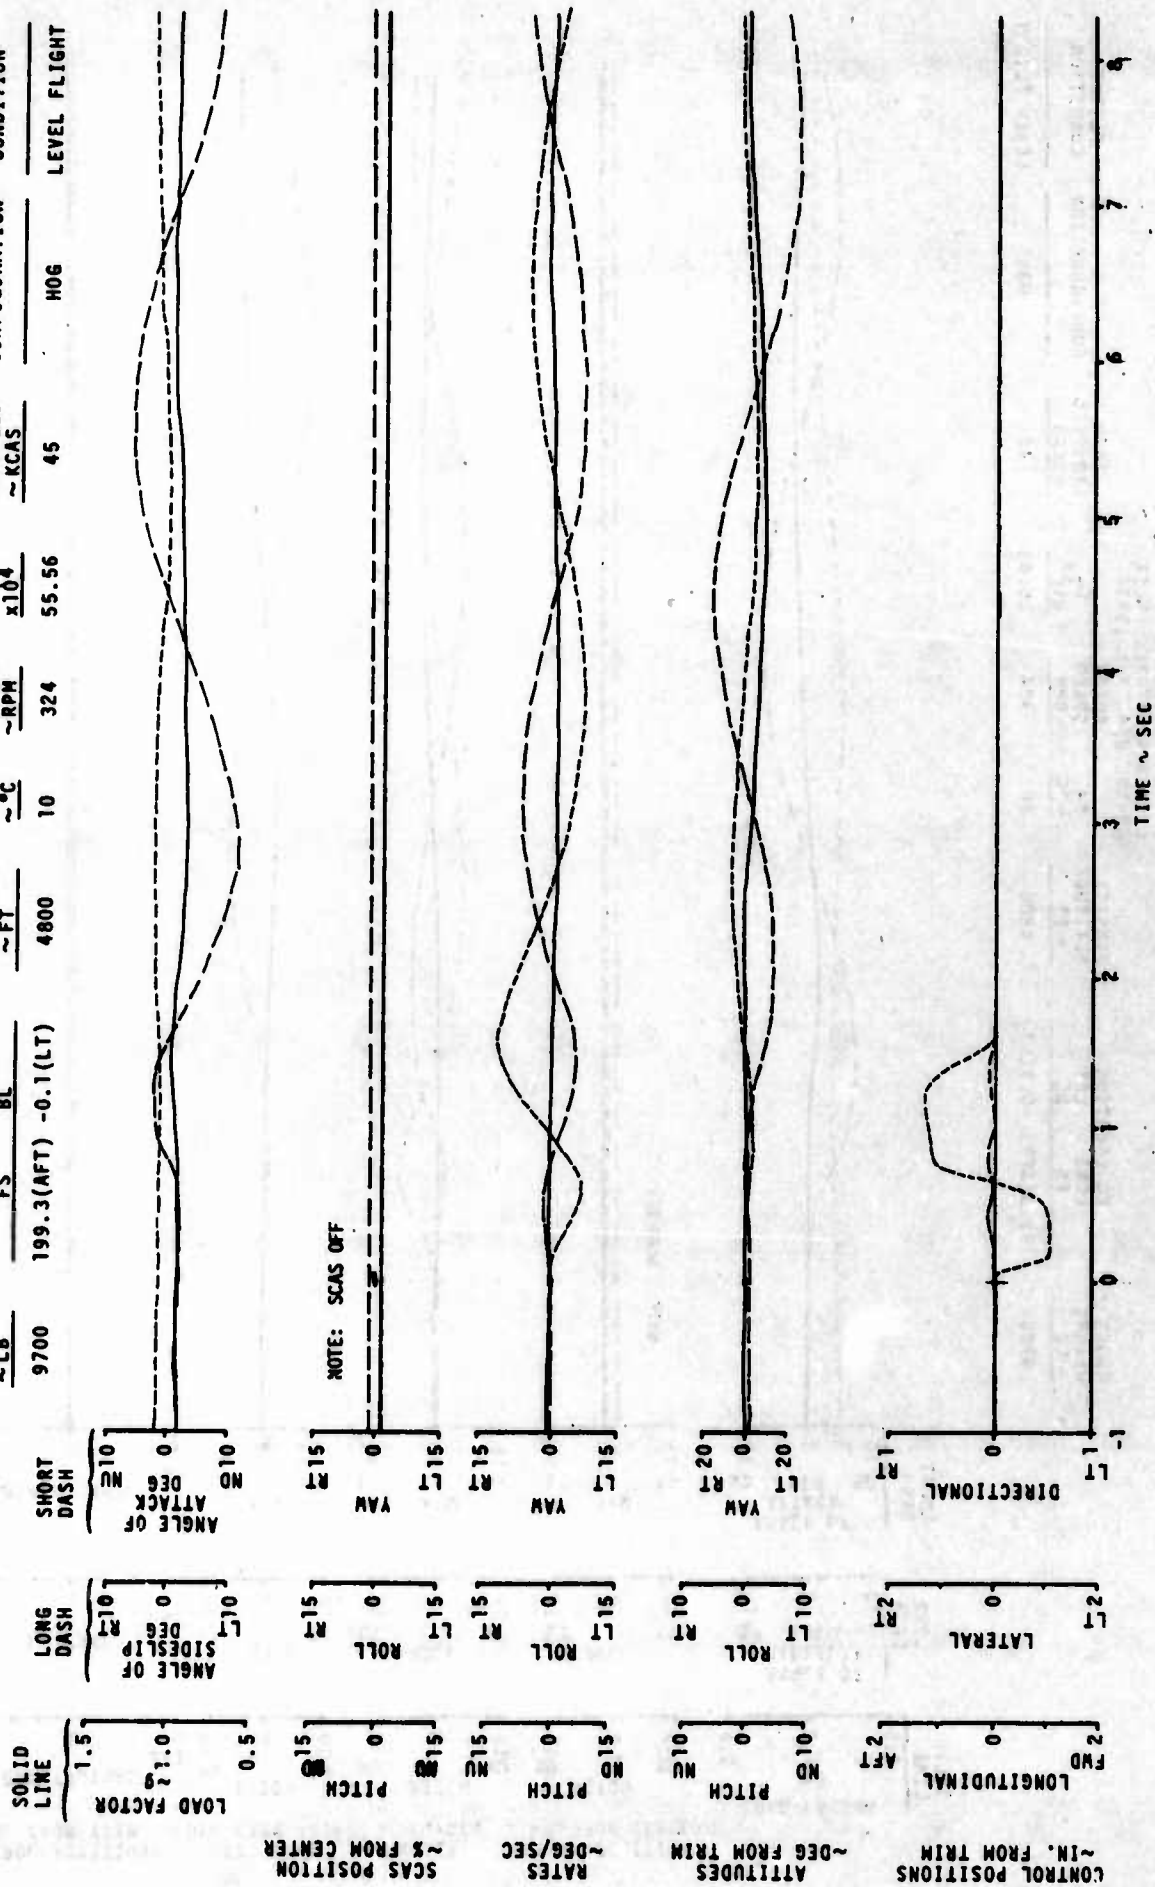
FIGURE 25  
MANEUVERING STABILITY  
YAH-1R USA S/N 70-13936

26. Maneuvering stability characteristics were evaluated at the conditions shown in table 1 with SCAS ON. Trim conditions were 120 and 124 KCAS at maximum continuous power zero sideslip level flight and 60 KCAS in a zero sideslip maximum power climb. The variation of longitudinal and lateral cyclic and pedal control positions with cg normal acceleration was determined by stabilizing the aircraft in constant-airspeed zero sideslip turns at incremental bank angles left and right. The collective control remained fixed during the maneuver and power and rotor speed varied as a function of the pitch cone coupling and the altitude variation during the turn. The quantitative results of the maneuvering stability evaluation are presented in figures 25 and 26, appendix E.

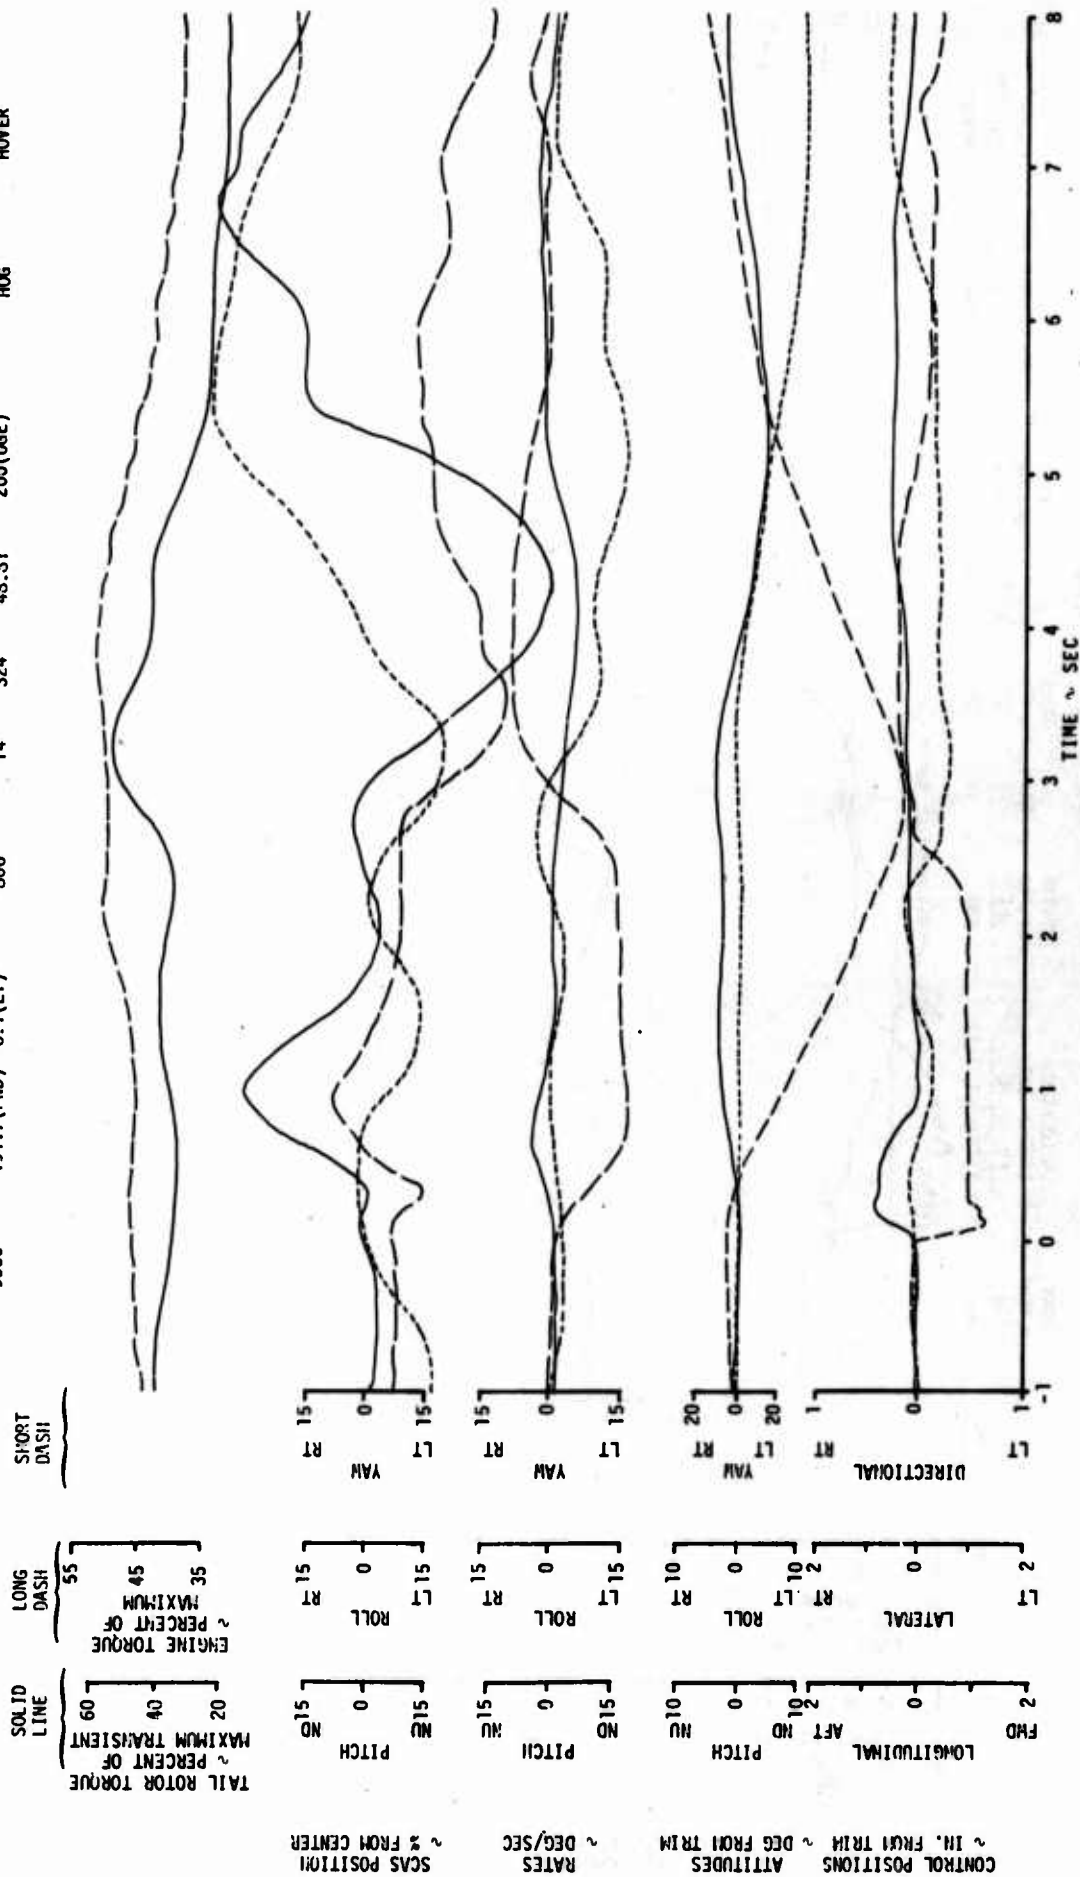
FIGURE 32  
LEFT DIRECTIONAL STEP  
YAHU-1R USA S/M 70-15936

GROSS HEIGHT -LB	CG LOCATION		DENSITY ALTITUDE -FT	OAT °C	ROTOR SPEED -RPM	C <sub>T</sub> ×10 <sup>4</sup>	SKID HEIGHT -FT	FLIGHT CONDITION
	LONG FS	LAT DL						
9570	131.7(F#)	-0.1(LT)	3000	14	324	48.66	10(IGE)	HOG
